Fire Towers, Lumber, and Corrosion - Should We Be Concerned?

Ed Engelman, December 3, 2020
engelman.ed@gmail.com

The Rock Rift Fire Observation Tower is located on Tower Mountain above the Cannonsville Reservoir in the Town of Tompkins, Delaware County, New York. This investigation will inform decisions to be made regarding its restoration.

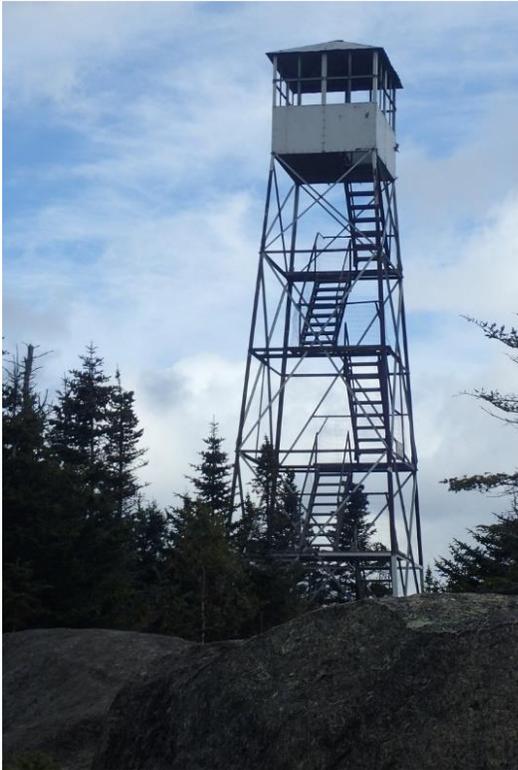
Pieces of the 100-year-old cross braces from the St. Regis Fire Tower were used in this investigation. The old braces were replaced by the Friends of St. Regis Fire Tower with newly manufactured hot dipped galvanized braces in 2018 and 2019

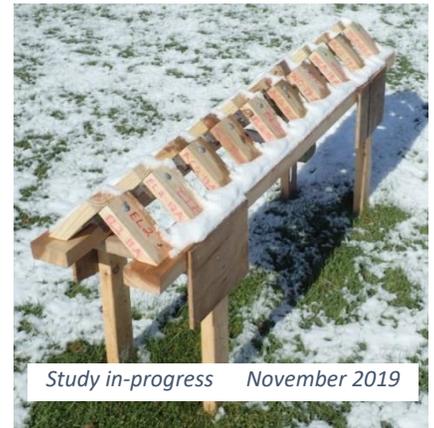
The steel that was in direct contact with white oak lumber rusted. This was readily evident on each sample. White oak lumber is quite acidic, and this result was not unexpected. The samples with the Grace® water and ice shield and the Rust-oleum® painted barrier did not show any rusting.

White oak lumber has several excellent qualities. It is strong, decay resistant, and a local woods product. This study shows that if white oak is attached to a galvanized steel surface that a barrier is needed to minimize corrosion. The ice and water shield is quick and easy to apply and does not require the drying time of a paint. The Grace® Ice and Water Shield stood up to removal of the lumber and maintained its integrity. The Rust-oleum® 5200 System DTM Acrylic paint also protected the steel. Portions of the paint pulled away from the steel upon disassembly.

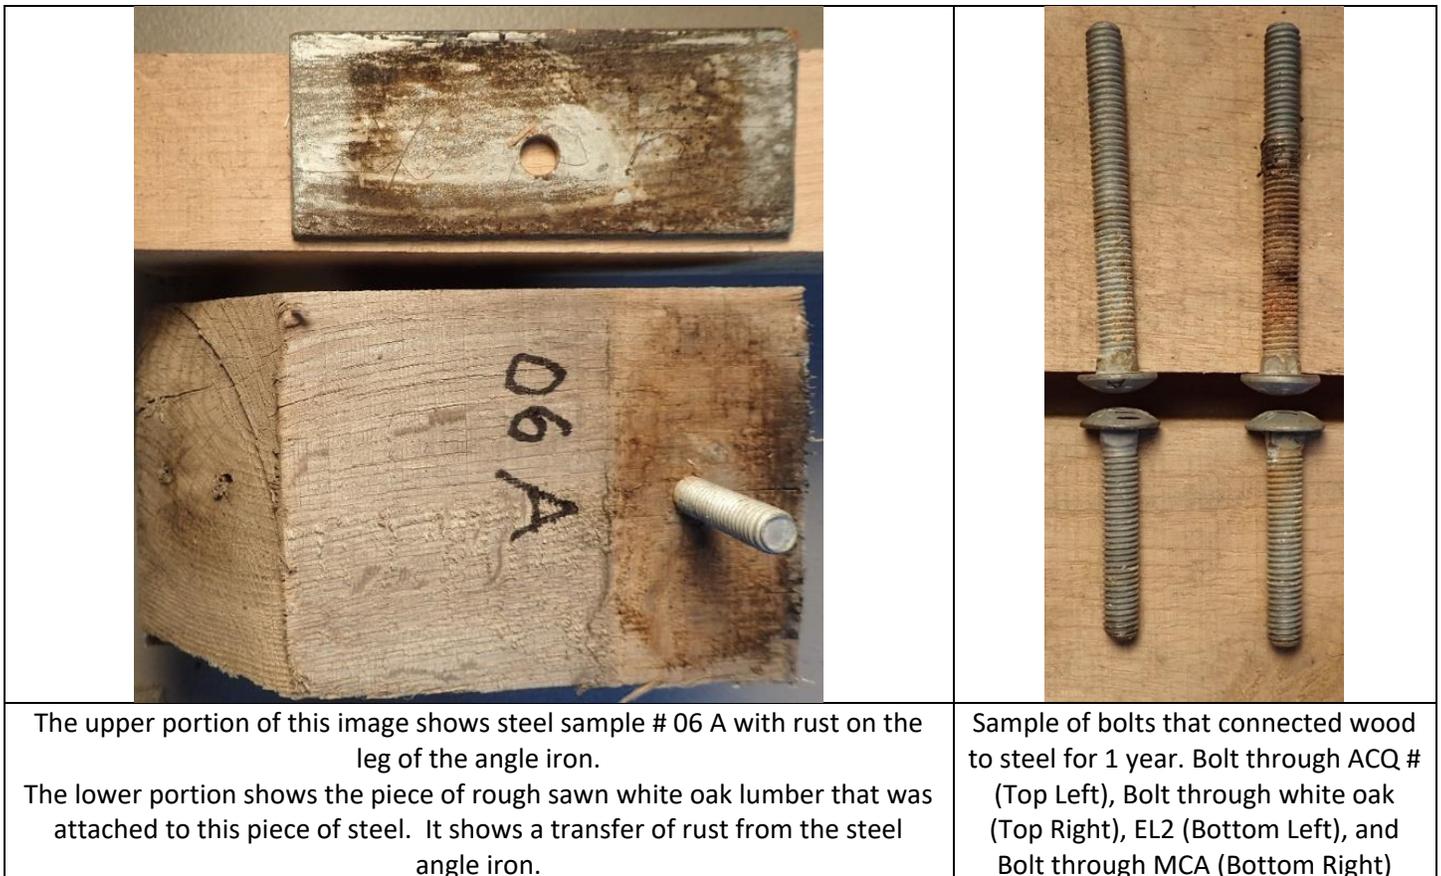
The bolts through the white oak lumber showed the most corrosion (WO). Moderate corrosion is seen along the threads of the bolts from the Alkaline Copper Quaternary (ACQ) pressure treated lumber samples. Light corrosion is seen along the bolts that were imbedded in the Micronized Copper Azole (MCA) pressure treated lumber. MCA lumber was developed to be less corrosive than ACQ. This demonstration supports that claim. Of the four lumbers used the MCA formulation used in this investigation is the only one recommended for ground contact. The others are only for non-contact or above ground use. Corrosion is not evident on the bolts in the Ecolife II treated lumber (EL2).

Perhaps the corrosion of the bolts in the white oak, ACQ, and MCA lumber is acceptable. Bolts can be viewed as an acceptable sacrifice as compared to the cleats of the stairs or the angle iron supporting the landings. Bolts can be replaced more easily than the steel structure of the fire tower.

We know that there will be a galvanic reaction between most available formulations of pressure treated lumber and galvanized steel. We know that there is corrosion from this reaction. We are not restoring the fire towers for the next 10 or 20 years. We are restoring them so that their structures and legacies are preserved far into the future. Perhaps it is prudent to install a barrier system during fire tower renovation between all lumber and galvanized steel.

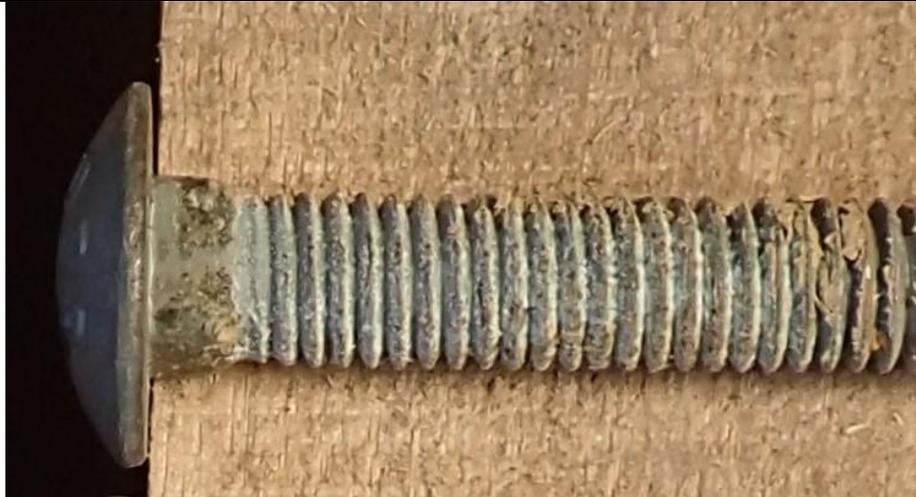
<p>The bolt on the left was imbedded in ACQ lumber. In addition to surface corrosion this close-up image shows pitting on the crest of the thread and along the thicker flank portion of the thread.</p>

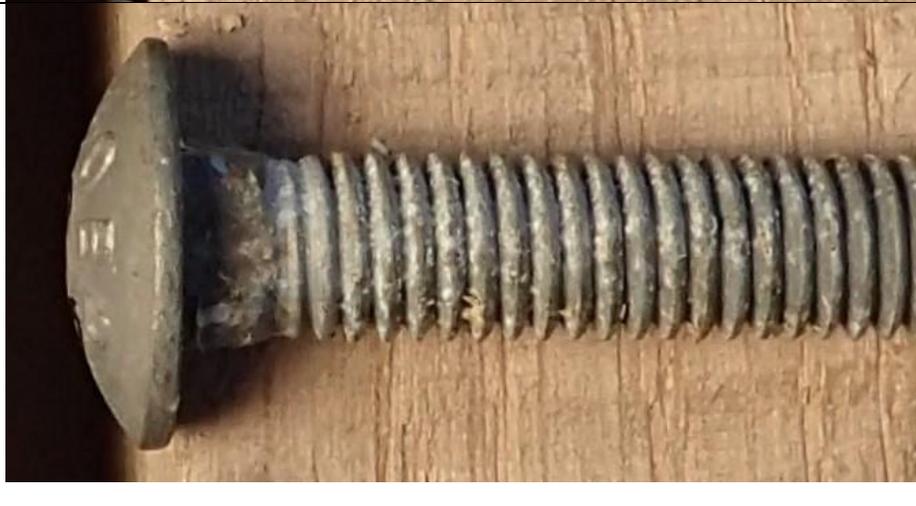
<p>The bolt on the left was imbedded in MCA lumber. It shows corrosion mostly on the crest of the thread.</p>
