Fire Towers, Lumber, and Corrosion - Should We Be Concerned?

Ed Engelman, December 3, 2020
engelman.ed@gmail.com

The Rock Rift Fire Observation Tower is located on Tower Mountain above the Cannonsville Reservoir in the Town of Tompkins, Delaware County, New York. This investigation will inform decisions to be made regarding its restoration.

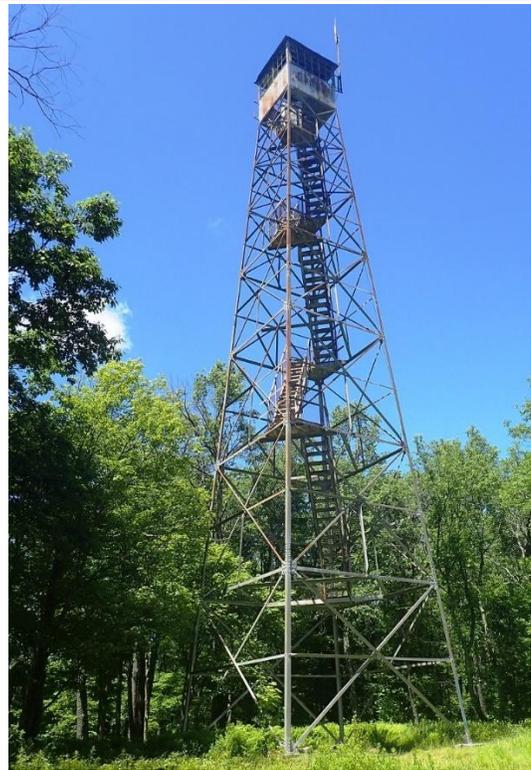
Pieces of the 100-year-old cross braces from the St. Regis Fire Tower were used in this investigation. The old braces were replaced by the Friends of St. Regis Fire Tower with newly manufactured hot dipped galvanized braces in 2018 and 2019

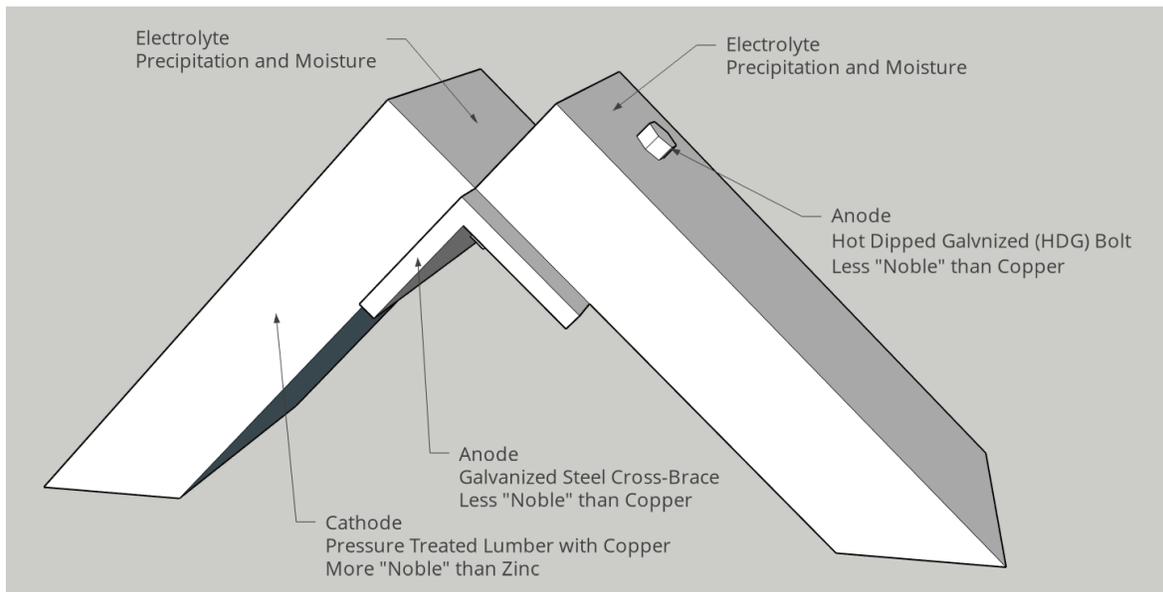
- Two or more metals with different corrosion potentials
- Contact between the two metals or metal bearing substances
- A conductive electrolyte solution such as water that creates a path for electrical conduction

However, size matters as to the amount of current generated by a galvanic reaction. The relative surface area (not mass) of each of the exposed metals is an important factor. If the area of the cathode (the noble metal – The copper in pressure treated lumber is noble relative to zinc) is very large, and the anode (The less noble zinc in the galvanized coating of the steel) is very small, the current produced is likely to be very high and the anode will corrode quickly. That is not the situation in this experiment with the angle iron. The surface area of the pressure treated lumber was approximately 460 sq. cm and the steel was approximately 219 sq. cm. This is a ratio of 2.1:1. Thus, we can expect that there is less of a galvanic current flowing and that it will not be as corrosive as many of the published laboratory test conditions. However, it is evident that the bolts with their much smaller area that are imbedded through the ACQ and MCA lumber are visibly corroding more than the angle iron attached to the lumber.

Perhaps the corrosion of the bolts in the white oak, ACQ, and MCA lumber is acceptable. Bolts can be viewed as an acceptable sacrifice as compared to the cleats of the stairs or the angle iron supporting the landings. Bolts can be replaced more easily than the steel structure of the fire tower.

We know that there will be a galvanic reaction between most available formulations of pressure treated lumber and galvanized steel. We know that there is corrosion from this reaction. We are not restoring the fire towers for the next 10 or 20 years. We are restoring them so that their structures and legacies are preserved far into the future. Perhaps it is prudent to install a barrier system during fire tower renovation between all lumber and galvanized steel.
