Should We Be Concerned About Corrosion?

Material choices when renovating steel fire towers

Ed Engelman, June 2022

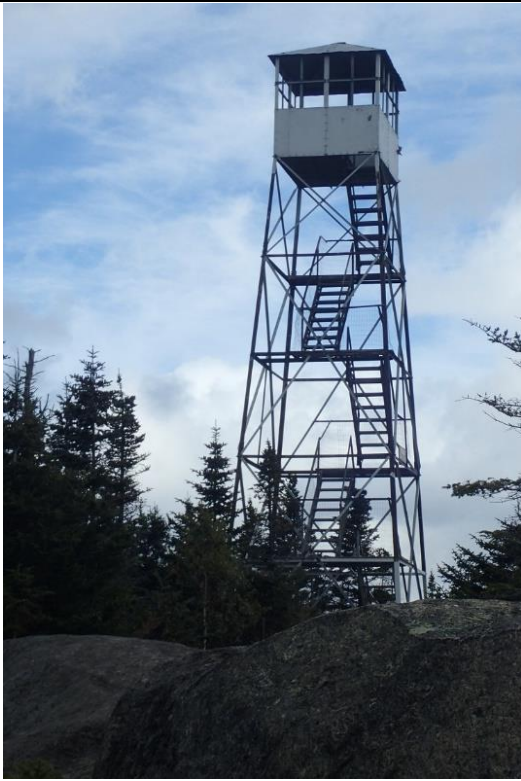
Pieces of the 100-year-old cross braces from the St. Regis Fire Tower in Franklin County, NY were used in this investigation. The old braces were replaced by the Friends of St. Regis Fire Tower with newly manufactured hot dipped galvanized braces in 2018 and 2019

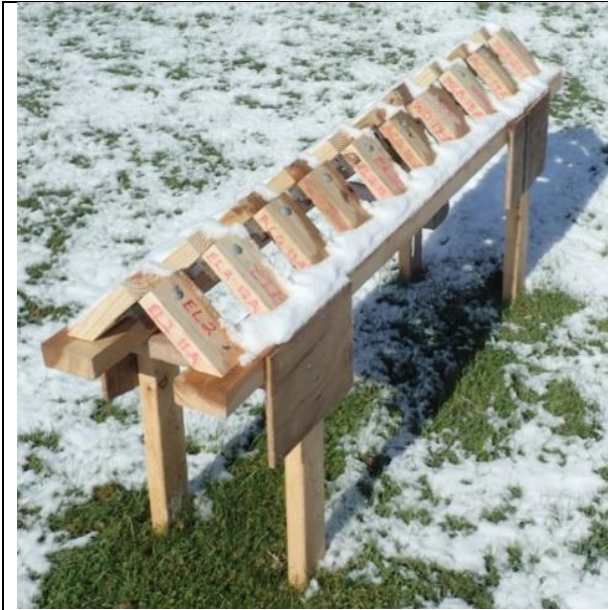
Image shows one of two test racks during the 2020 -2021 corrosion study.

Six samples of each lumber were attached to the old, galvanized steel from the St. Regis tower without any barrier materials placed between the lumber and the steel. Two samples of each lumber were attached to steel with a barrier of Rust-oleum® 5200 System DTM Acrylic paint. Two samples of each lumber were attached to steel pieces with a barrier of Grace® Water and Ice Shield as a barrier between them. This material is a membrane of rubberized asphalt adhesive backed by a layer of high density cross laminated polyethylene film. (Caution: avoid barrier films that contain carbon black as a filler. The carbon black will react with stainless steel and result in corrosion of the stainless-steel.) The samples were attached to frames and were set outdoors in Chenango County, NY from November 2019 to November 2020.

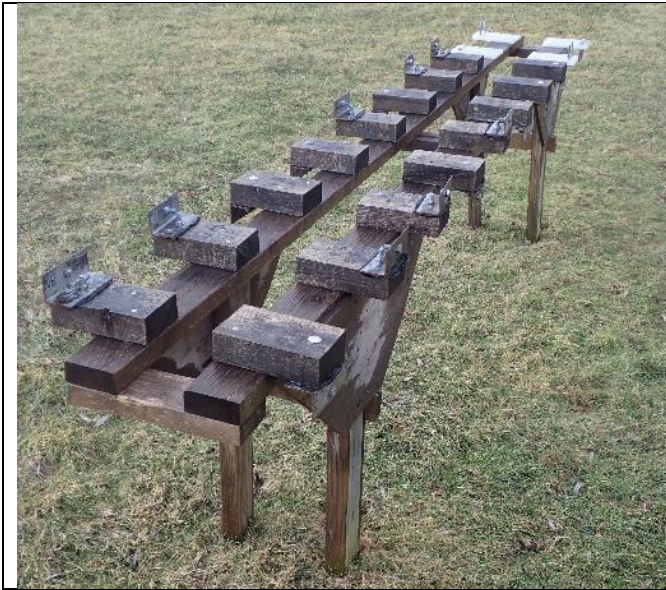
Image to the left shows the test rack from the 2021 – 2022 study comparing the corrosion of oak lumber on stainless-steel vs. hot dipped galvanized nuts and bolts. This image was taken 10 months after the start of this part of the two-year study.

Galvanized steel from the St. Regis fire tower was attached to samples of white oak lumber separated by a barrier film of Grace® Water and Ice Shield. Half of the samples were attached with stainless-steel bolts and half with hot dipped galvanized bolts. Also, SS bolts and HDG bolts were attached to nylon plates with nuts of the same and different composition.

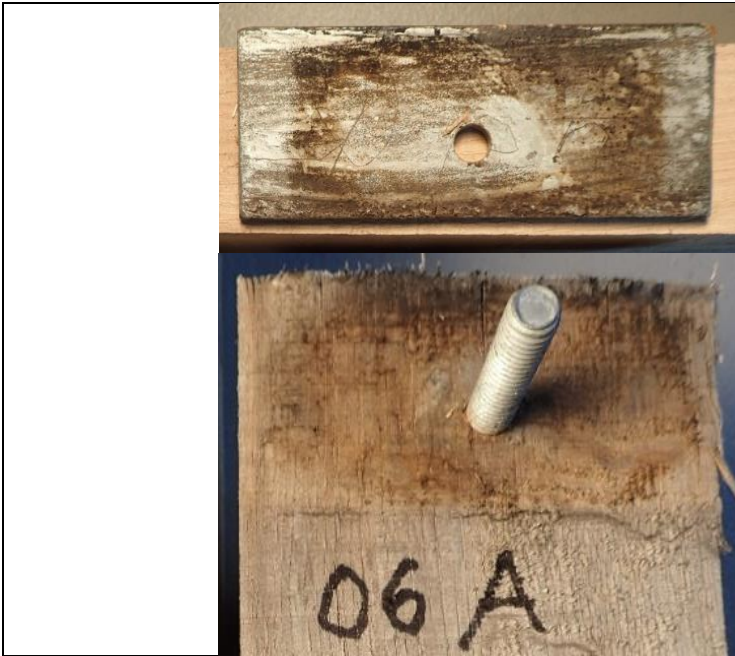
The upper portion of this image shows steel sample # 06 A with rust on the leg of the angle iron.
 The lower portion shows the piece of rough sawn white oak lumber that was attached to this piece of steel. It shows a transfer of rust from the steel angle iron.

The first study demonstrated that white oak lumber attached to a galvanized steel angle iron without a barrier film, resulted in significant rusting and corrosion within one year. With a barrier film, the steel from the cross braces was protected. The ice and water shield is quick and easy to apply and does not require the drying time of a paint. The Grace® Ice and Water Shield stood up to removal of the lumber and maintained its integrity. The Rust-oleum® 5200 System DTM Acrylic paint also protected the steel. Portions of the paint pulled away from the steel upon disassembly.

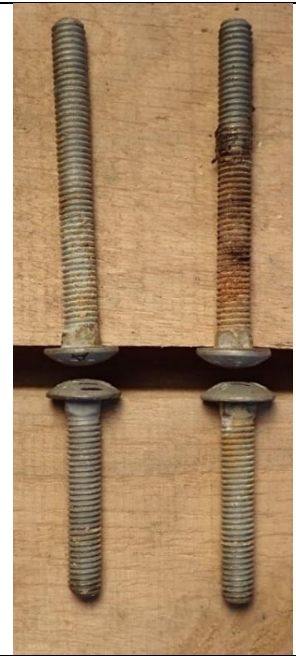
Sample of bolts that connected wood to steel for 1 year. Bolt through ACQ # (Top Left), Bolt through white oak (Top Right), EL2 (Bottom Left), and Bolt through MCA (Bottom Right)

In the 2019-2020 study, the bolts through the white oak lumber showed the most corrosion. This occurred in the samples between the white oak and the bolts even when a barrier was used between the angle iron from the St. Regis fire tower and the oak lumber. Moderate corrosion formed along the threads of the bolts from the Alkaline Copper Quaternary (ACQ) pressure treated lumber samples. Light corrosion was noted along the bolts that were imbedded in the Micronized Copper Azole (MCA) pressure treated lumber. MCA lumber was developed to be less corrosive than ACQ. This demonstration supports that claim. Of the four lumbers used, the MCA formulation used in this investigation is the only one labeled for ground contact. The others are only for non-contact or above ground use. Corrosion is not evident on the bolts in the Ecolife II treated lumber (EL2).

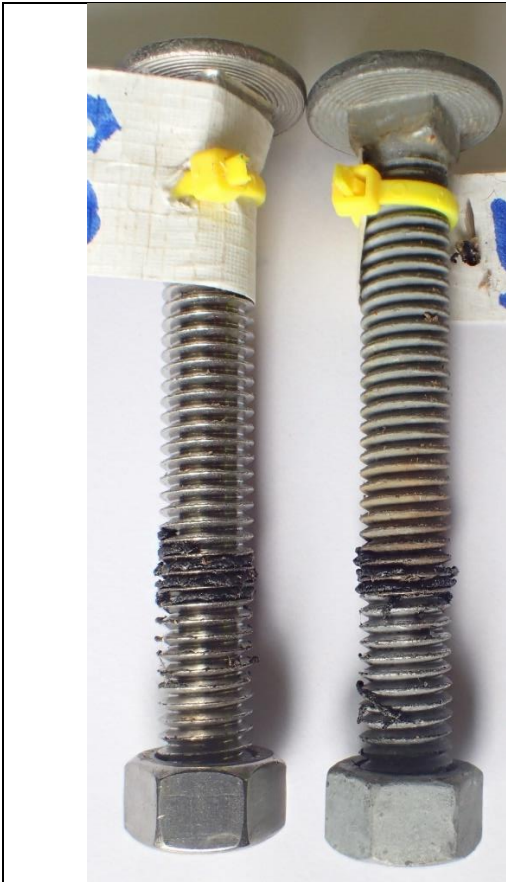
18-8 stainless steel bolt (left) shows no evidence of corrosion after one year of weathering connecting white oak lumber to century old, galvanized steel from the St. Regis fire tower. (Sample 06-A)

Hot dipped galvanized bolt (right) shows corrosion after one year of weathering in upstate New York, connecting white oak lumber to galvanized steel. (Sample 15-B)

Both bolts show a black residue from the Grace® Water and Ice Shield below the portions that were embedded white oak lumber.

The 2021-2022 study examined the performance of 18-8 stainless-steel vs hot dipped galvanized bolts used to attach white oak lumber in an outdoor setting. The stainless-steel bolts appeared to be unaffected by the acidic white oak.

The 2021 to 2022 study was designed to look for corrosion of 18-8 stainless-steel hardware and its influence on the connected HDG angle iron. The study compared the performance of the SS to the corrosion of HDG bolts when used to connect white oak lumber to HDG steel in an outdoor setting (annual precipitation of about 43 inches). The stainless steel did not promote or show visible signs of corrosion. Rust formed along the threads of the HDG bolts.

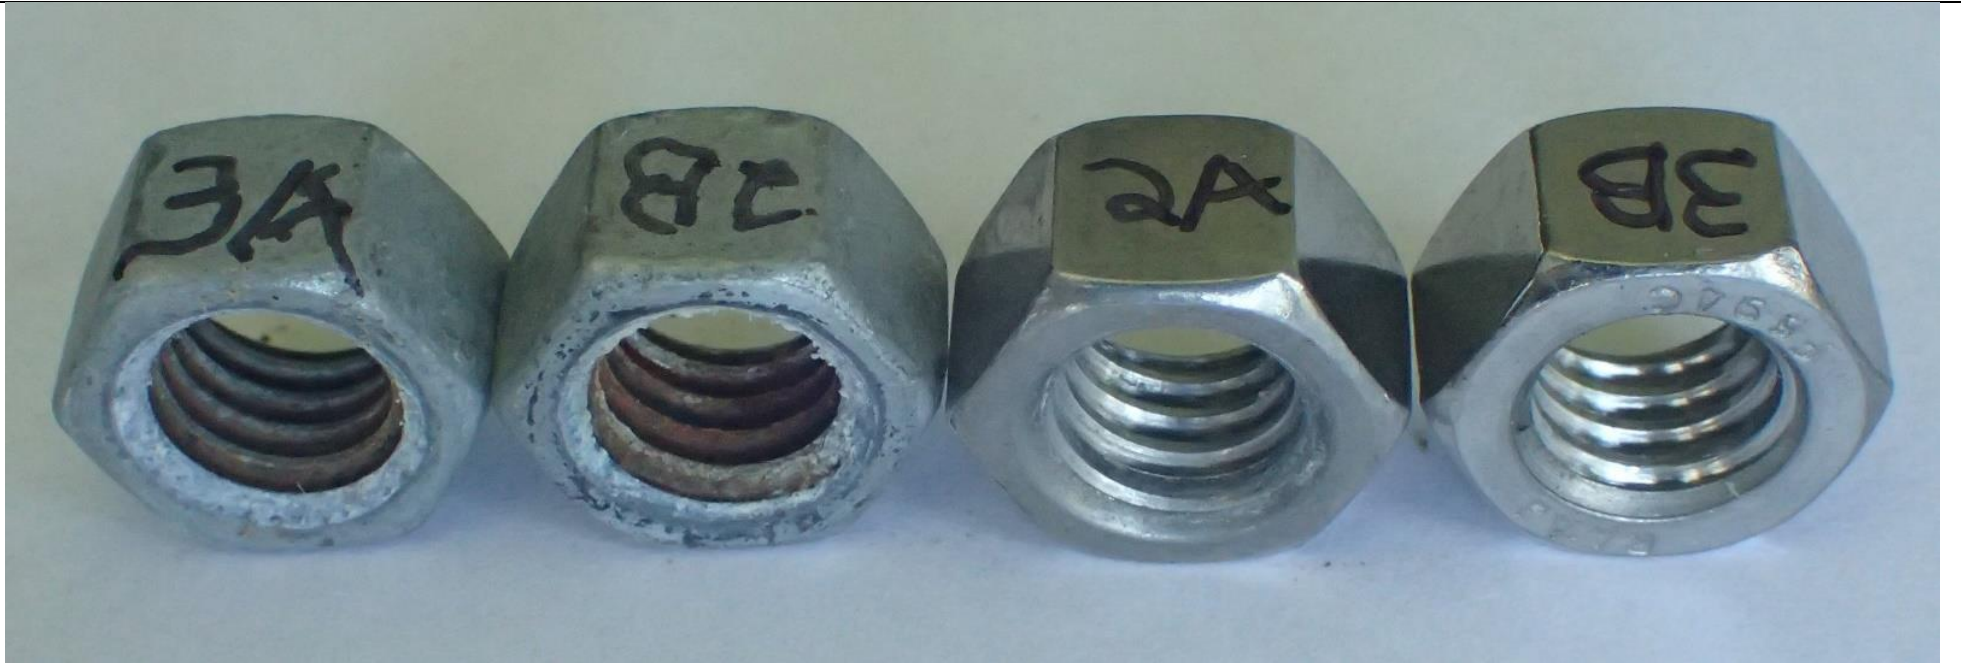
The hex nuts above were paired with bolts of similar and dissimilar metals and fastened to sheets of nylon. They were placed outdoors for one year. Sample 3A HDG nut attached to HDG bolt, Sample 2B HDG nut attached to SS bolt, Sample 2A SS nut attached to HDG bolt, and Sample 3B SS nut attached to SS bolt.

The 2021 to 2022 study also examined samples of mixing dissimilar metals. SS nuts were connected to HDG bolts. HDG nuts were connected to SS bolts. Nuts and bolts of the same material were also connected to compare to the effects of mixing dissimilar metals. It was noted that there was some corrosion on the internal threads of the HDG nuts connected to HDG bolts. The most corrosion was found when a HDG nut was attached to a stainless-steel bolt. Corrosion was not evident on the SS nuts when attached to a HDG or SS bolt (see image above). This result demonstrated that with a larger surface area of the cathode material (SS) and a much smaller surface area of the anode, (HDG) greater corrosion will occur at the anode.
